FINAL REPORT

INVESTIGATION OF THE REACTION OF TITANIUM WITH HYDROGEN

NATIONAL AERONAUTICS & SPACE ADMINISTRATION

Contract NAS 9-7549

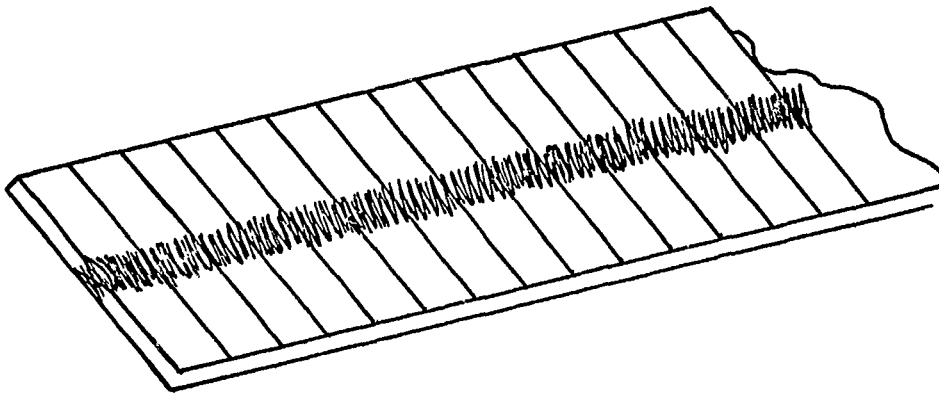
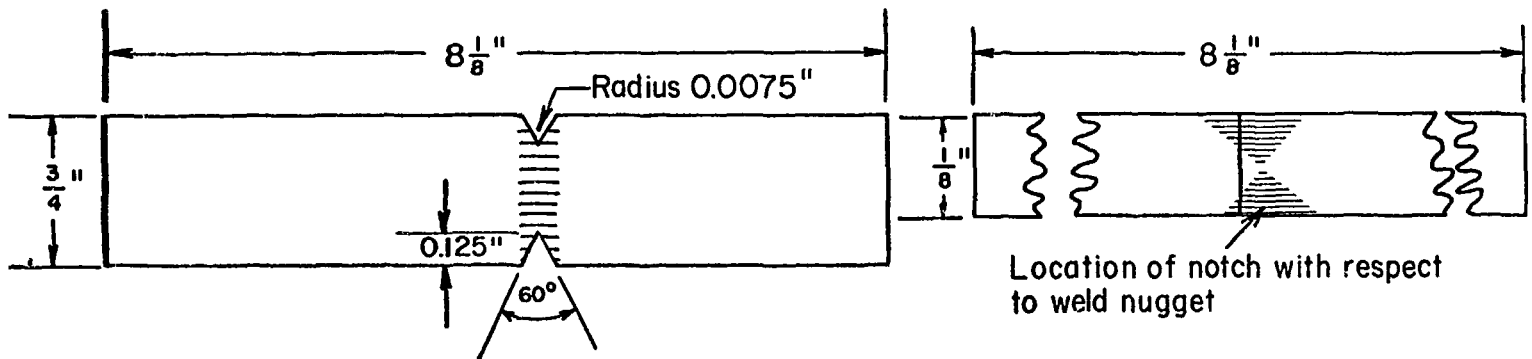
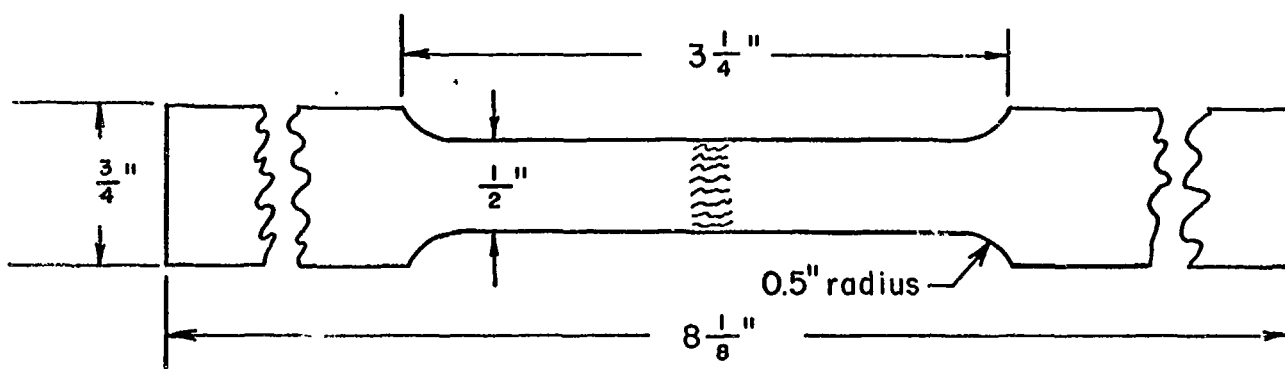
FIGURE 23. TEST SAMPLE LOCATION AND SAMPLE DIMENSION

a. Sample Blank Cutting Procedure

b. Notched Test Sample ( $K_t = 6$ )

c. Unnotched Test Sample

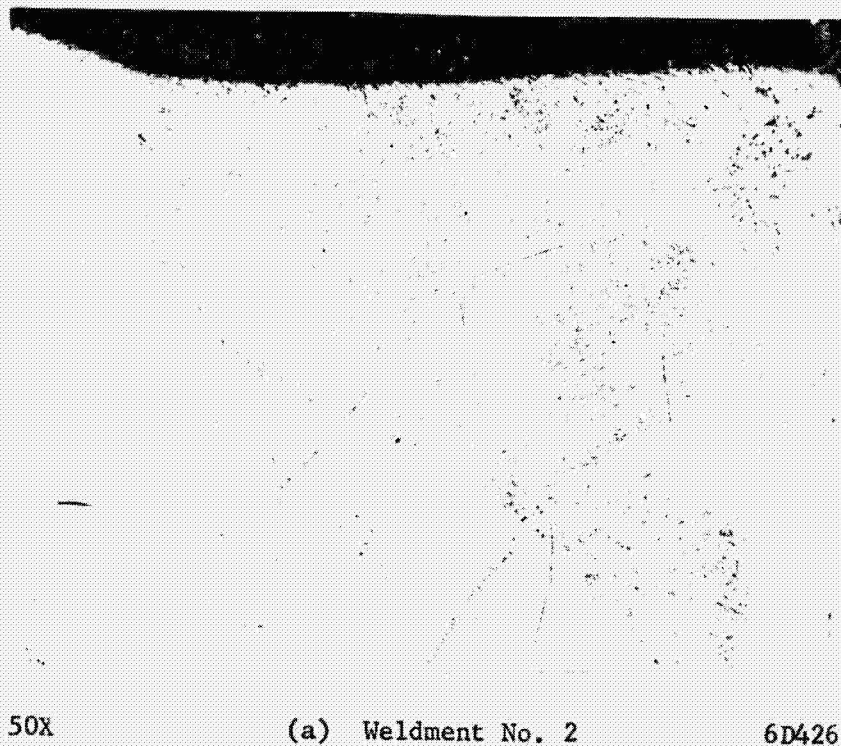
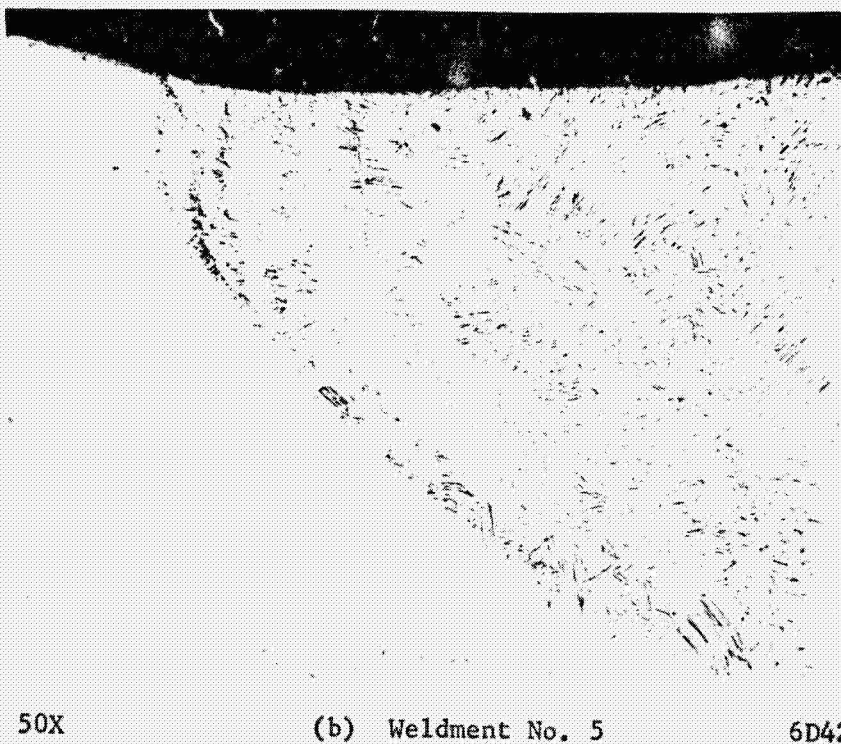
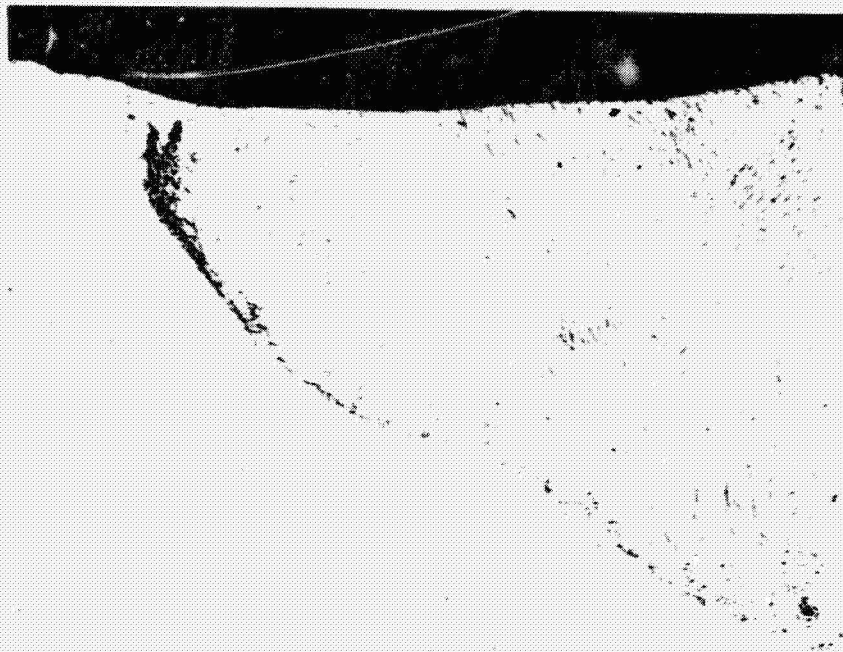
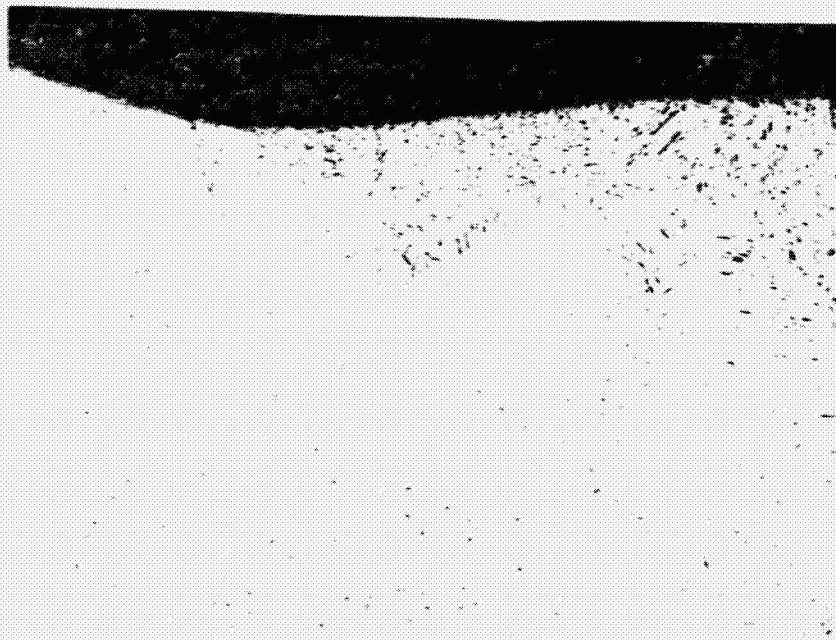
FIGURE 24. HYDRIDE PRECIPITATED IN WELD AREA

Base Plate  
Ti-6Al-4V  
65 ppm H<sub>2</sub>

Filler  
Ti-50A  
65 ppm H<sub>2</sub>

Base Plate  
Ti-6Al-4V  
190 ppm H<sub>2</sub>

Ti-6Al-4V plate is to the left, Ti-50A  
filler metal to the right.

Filler  
Ti-50A  
145 ppm H<sub>2</sub>

Base Plate  
Ti-6Al-4V  
70 ppm H<sub>2</sub>

Metallographic examination showed hydride precipitation in all the welds except the one which consisted of Ti-6Al-4V welded with Ti-6Al-4V filler metal. Bands of hydride were observed at the weld metal-heat affected zone interface of welds made to join high hydrogen Ti-6Al-4V sheet using unalloyed titanium filler metal. The amount of banding was heavier in a weld made using high hydrogen unalloyed titanium filler, but was also present in a weld using low hydrogen unalloyed titanium filler.

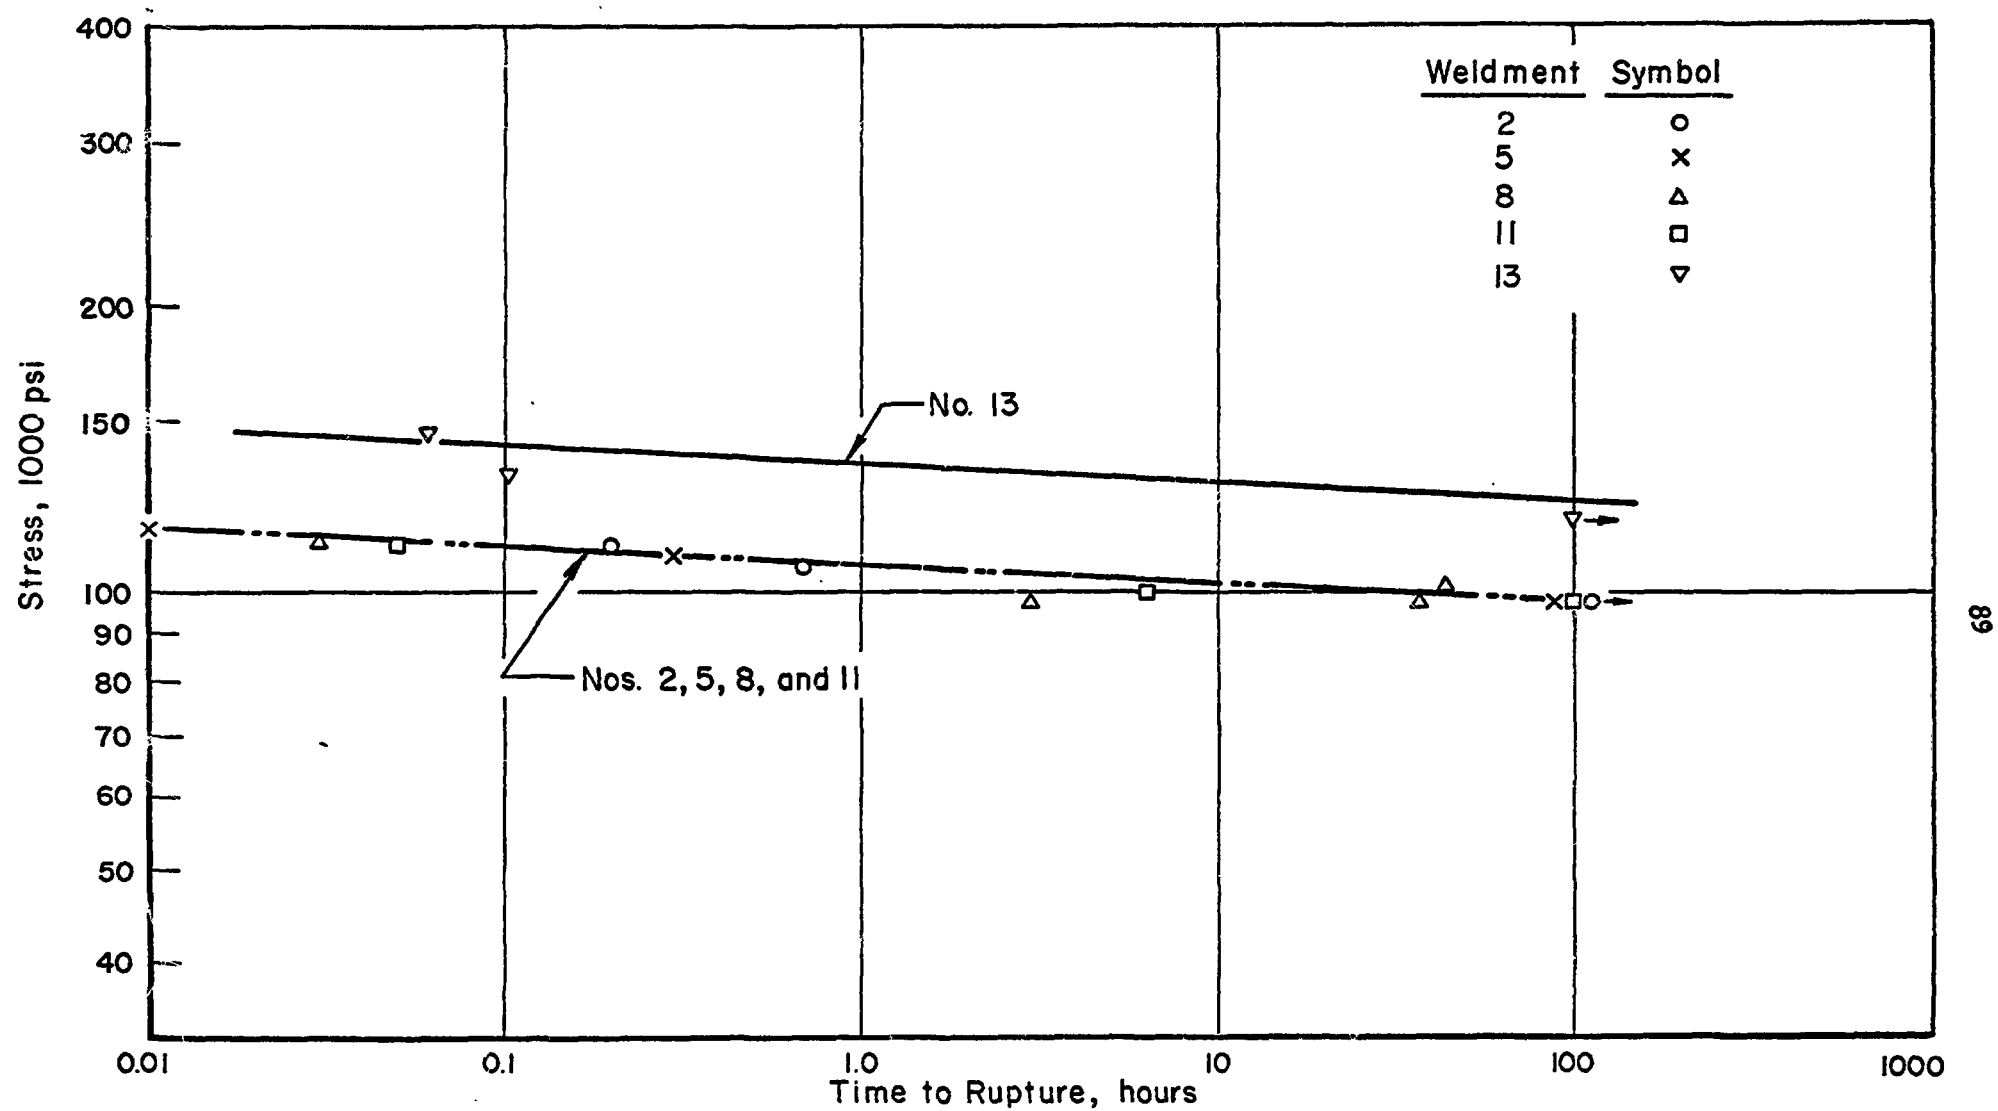
FIGURE 25. STRESS RUPTURE CURVES FOR NOTCHED SHEET SAMPLES AT ROOM TEMPERATURE

Weldment Number	Stress, psi	Time to Failure, hr
2	111,900	0.2
	105,600	0.7
	97,000	112.4 discontinued
5	116,600	0.01
	110,000	0.3
	97,000	92.5
8	111,600	0.03
	100,000	43.6
	97,000	3.0
	96,000	37.0
11	111,900	0.05
	100,300	6.4
	97,000	100.0 discontinued
13	148,300	0.06
	133,500	0.10
	120,000	100.0 discontinued
